## Mechanical Cutting Case Histories

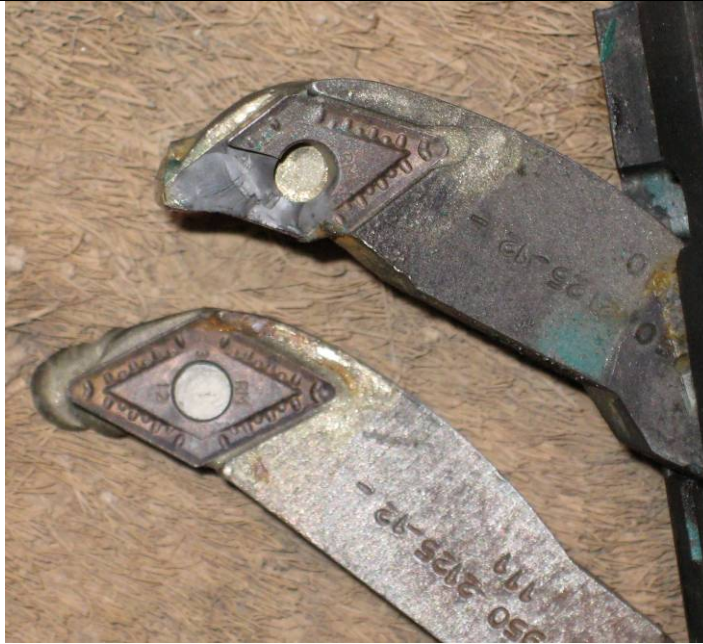
The tubing and BHA were pulled OOH, the cutter was checked at surface showing good indications that the mandrel had been cut. 1 blade had a small chip out of the insert. (as shown)
