## Milling / Under-reaming Case Histories

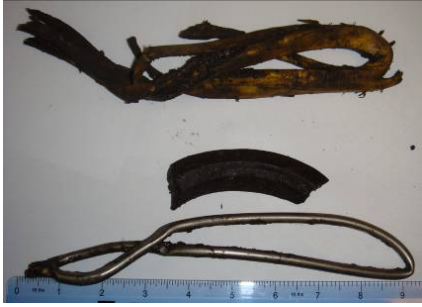
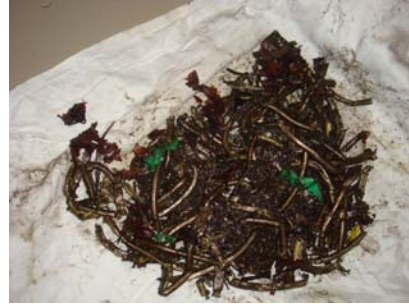
After initially attempting to open the valve with and a CIV Shifting Tool, the valve was still closed. A Venturi Jet Junk Basket was run and recovered some debris from above the valve prior to milling.

Debris retrieved in the VJJB

Welltonic manufactured a 3.20" OD mill to open up the ball to drift ID The Valve was milled out successfully with a 2-7/8" WellDrill motor and the well was then put on production.
